S-E-C-R-E-T REPORT

COUNTRY Poland

SUBJECT Mieleo WSK Aircraft Factory

Mielec WSK Aircraft Factory

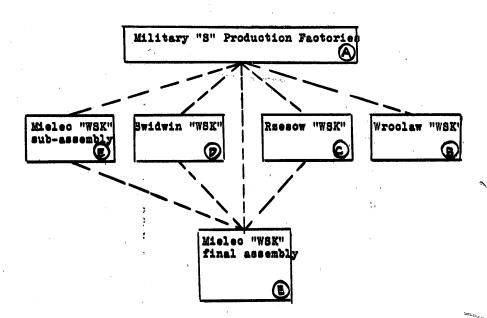
Figure 1: Production flow diagram of the Polish Jet Aircraft Industry.

- The Polish jet aircraft industry was spread among many factories producing a variety of parts for final assembly in Mielec. Figure 1 on page 11 is a production flow diagram of the Polish Jet Aircraft Industry, showing the movement of items first manufactured in military "S" production factories through four sub-assembly points to final assembly at Mielec. The following letters in parentheses refer to the corresponding letters on the figure:

- (A) Many of the "S" (military) production factories in Poland produced various small aircraft parts for engines, airframes, and armament. These were completed and shipped to the subassembly plants for further use in the production effort.

- (B) The Wroclaw "WSK" manufactured various precision items used in jet engines and complex aircraft hydraulic and electrical systems. This plant was construction and was 25X1 supposedly destroyed This entire site, including the underground sections, was reconstructed by the Poles prior to 1949.

- (C) The Rzesow "WSK" manufactured primarily jet aircraft engines; however, they occasionally produced conventional engines.

- (D) The Swidwin "WSK" primarily manufactured helicopters (SMI-1), in series production, which were to be exported. It also produced parts for airframes, tails, flaps, and elevators. This new factory was completed and began production in 1952.
- (E) The Mielec "WSK" also maintained a sub-assembly department for manufacturing airframes.

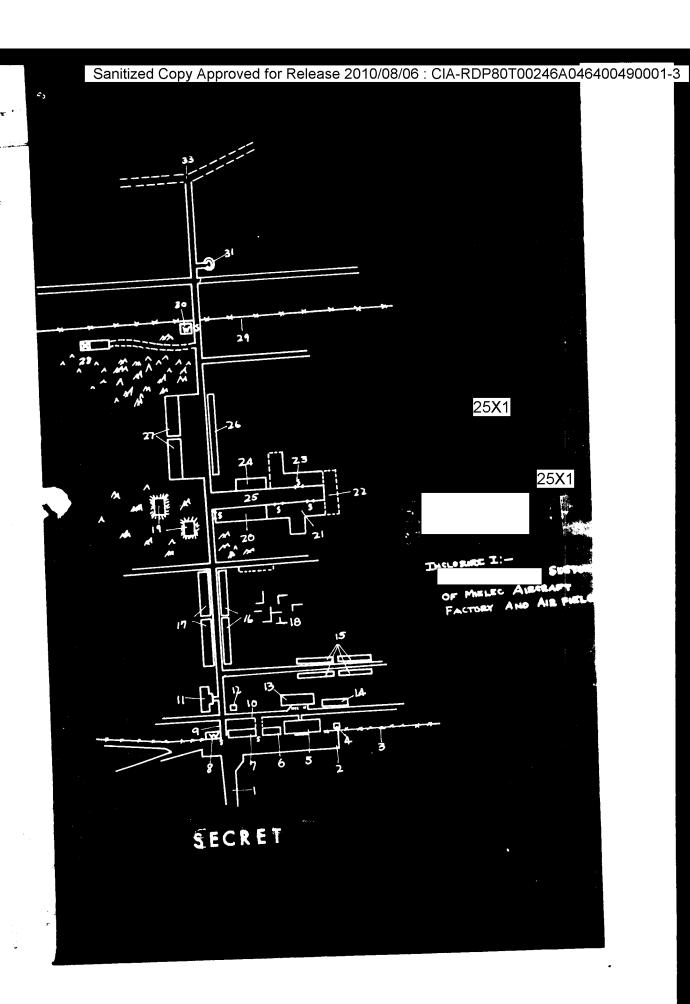
- Inclosure 1 is a _____sketch of the Mielec Aircraft Factory and Airfield. Numbers in parentheses below refer to corresponding numbers on the inclosure.

- (1) Stone and Asphalt Highway 10 meters wide, leading from the factory area to the workers housing area. The distance to the housing area was approximately 2.5 kilometers.

- (2) Stone Parking Area measuring 60 x 150 meters. This was believed to be used by official vehicles.
 - (3) Fence two meters high, of wire mesh topped with one meter of barbed wire. This enclosed the entire factory area.

- (4) Transformer Station a one-story, concrete building measuring 4 x 4 x 4 meters. ______ this installation received its electric power from the city power supply. 25X1

- (21) Sub-assembly Area a "T"-shaped, one-story, steel and concrete structure measuring approximately 60 x 30 x 20 meters. All portions of the air frame were assembled here, including the fuselages, tails, and wings. The most noticeable type of machine located here were large welding jigs.

- (31) Compass Testing Equipment a round turntable installation; it was 12-15 meters in diameter and constructed of steel and wood within a concrete foundation, which was marked with different compass points. A new aircraft would be parked at a designated point on the turntable; the turntable would begin to rotate, and the pilot would check his magnetic compass readings with the corresponding figures on the concrete foundation.

- (32) Runway measuring approximately 2000 x 60 meters. It was constructed of concrete, block sections, measurements unknown. A one-meter-wide amphalt strip ran down the center of the runway and was used primarily for orientation purposes. This runway had an 300-400 meter overrun on the eastern end and
